Customer
Sample Report

Home
1234 Main Street
Anywhere, GA 31234

Inspected By
Steve Mahaffey

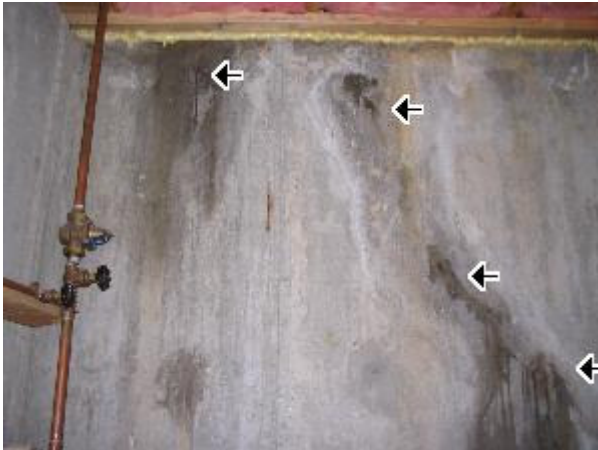
1.0 FOUNDATIONS (Report signs of abnormal or harmful water penetration into the building or signs of abnormal or harmful condensation on building components.)

There is water coming in at the top of the foundation wall and in a small hair line crack. The water appears to be entering from somewhere around the rock on the front stoop area. This could be something as simple as flashing or caulk to repair. Unable to determine the extent of water intrusion or how often it will occur.

There is water coming in at the top of the foundation wall and in a small hair line crack. The water appears to be entering from somewhere around the rock on the front stoop area. This could be something as simple as flashing or caulk to repair. Unable to determine the extent of water intrusion or how often it will occur.

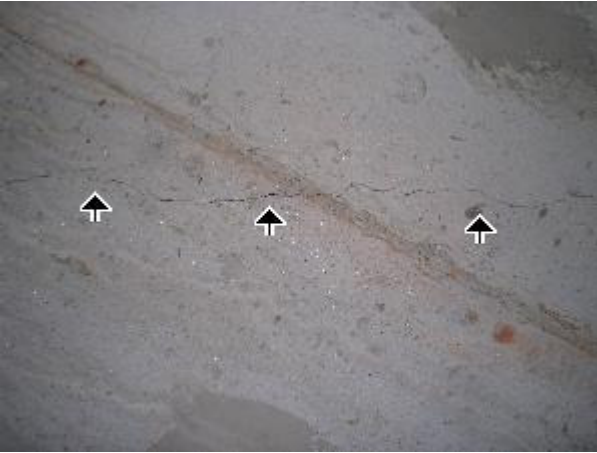
1.1 FLOORS (Structural)

There are some minor cracks in the basement and garage floors that need to be sealed with a concrete sealant.

There are some minor cracks in the basement and garage floors that need to be sealed with a concrete sealant.

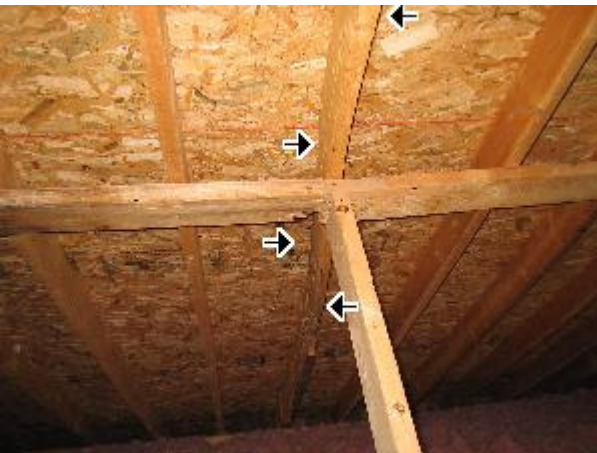
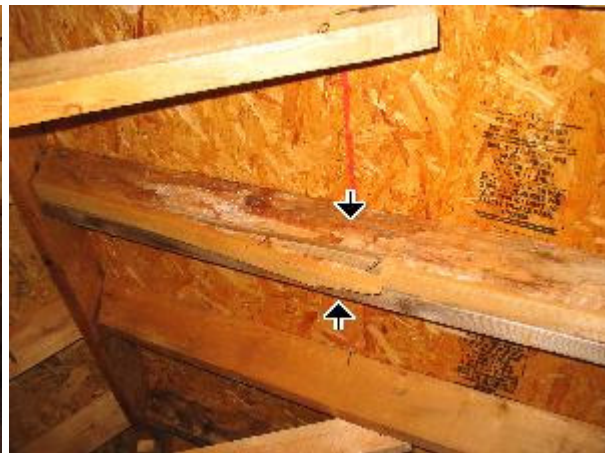
1.5 ROOF STRUCTURE AND ATTIC

There are two rafters in the attic that are broken and have had some repair but both need further repair. These should be scabbed on both sides. The rafter on the higher level of the attic should be scabbed from top to bottom on both sides due to the bows and cracks in it. Attic view.

There are two rafters in the attic that are broken and have had some repair but both need

further repair. These should be scabbed on both sides. The rafter on the higher level of the attic should be scabbed from top to bottom on both sides due to the bows and cracks in it. Attic view.

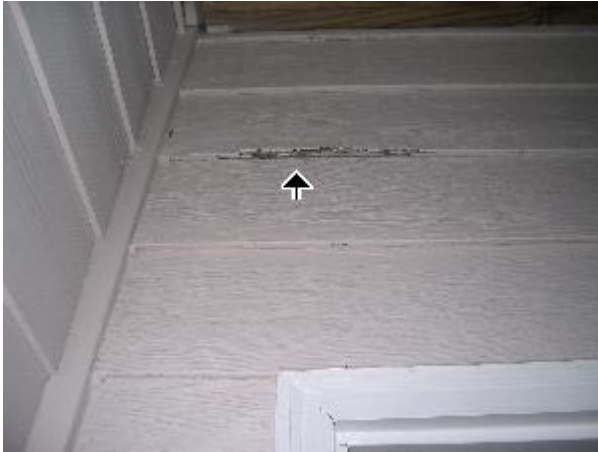
2.0 WALL CLADDING FLASHING AND TRIM

There is some siding around the basement door up to the bottom of the deck that needs to be replaced.

There is some siding around the basement door up to the bottom of the deck that needs to be replaced.

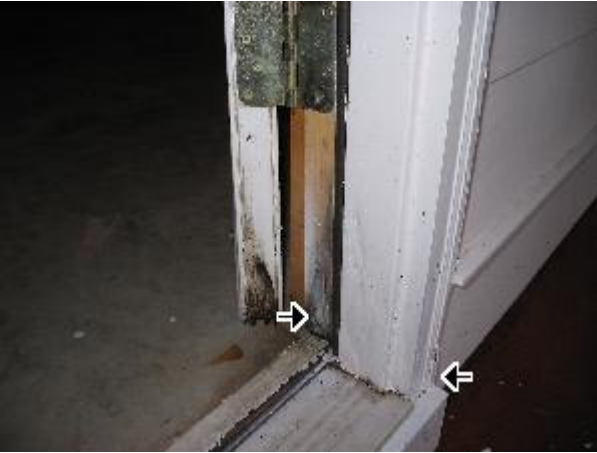
2.1 DOORS (Exterior)

Comments: Inspected
The door jam in the basement has some rot and the trim should be replaced.

The door jam in the basement has some rot and the trim should be replaced.

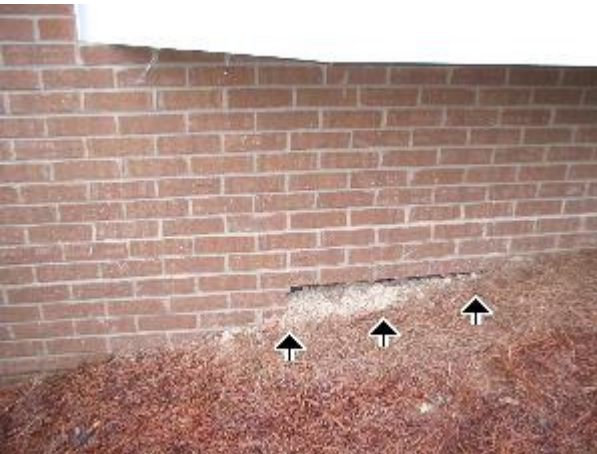
2.4 DECKS, BALCONIES, STOOPS, STEPS, AREAWAYS, PORCHES AND APPLICABLE RAILINGS

Comments: Inspected
There is an exposed area under the bay in the front where dirt level should be brought up to the brick.

There is an exposed area under the bay in the front where dirt level should be brought up to the brick.

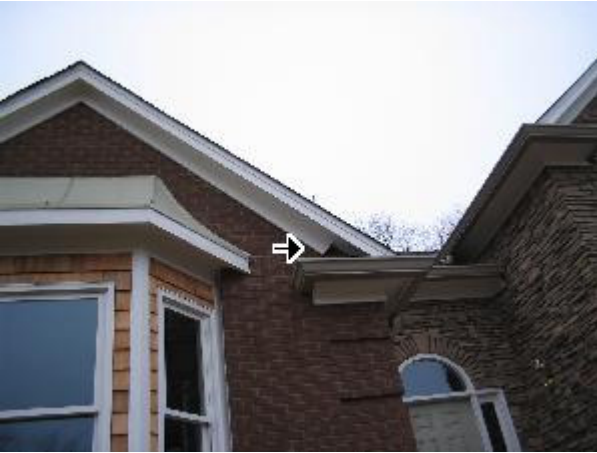
2.6 EAVES, SOFFITS AND FASCIAS

Comments: Inspected, Repair or Replace
The fascia on the front, where the rock and brick were added, was not run all the way to the bottom of this area. This should be completed.

The fascia on the front, where the rock and brick were added, was not run all the way to the bottom of this area. This should be completed.

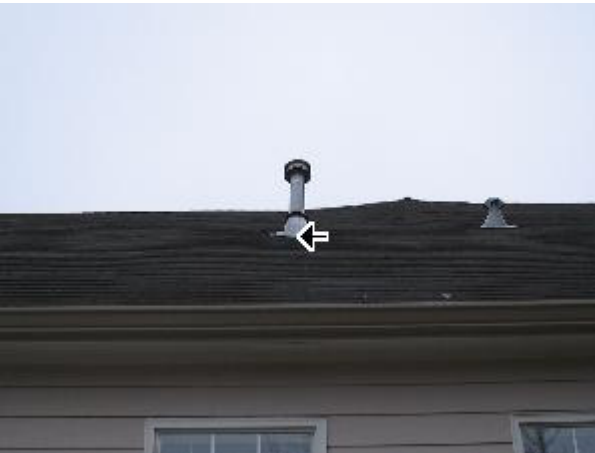
3.2 SKYLIGHTS, CHIMNEYS AND ROOF PENETRATIONS

There is a metal vent pipe exiting the roof on the garage side that needs the flashing put back under the shingles.

There is a metal vent pipe exiting the roof on the garage side that needs the flashing put back under the shingles.

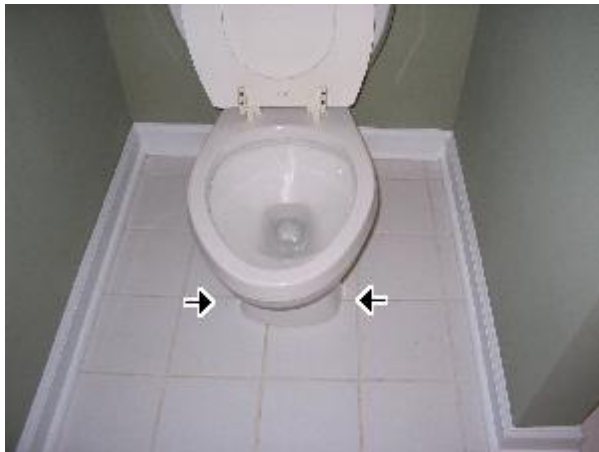
Picture 1

The toilet in the shared hall bath is loose at the floor and should be re-secured. Picture 1.

The toilet in the shared hall bath is loose at the floor and should be re-secured. Picture 1.

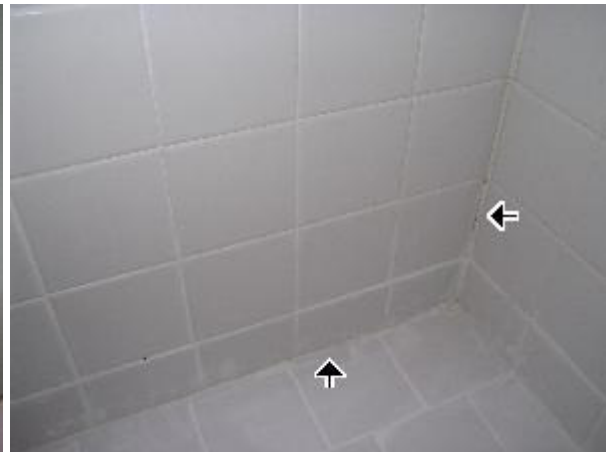
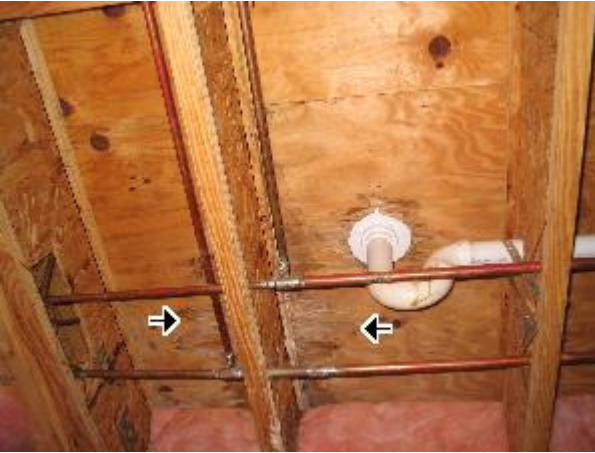
Picture 2

There are water stains under the master bath shower on the sub floor. This could be a result of shower needing to be re-grouted. It was dry at the time of inspection. Pictures 2 & 3.

There are water stains under the master bath shower on the sub floor. This could be a result of shower needing to be re-grouted. It was dry at the time of inspection. Pictures 2 & 3.

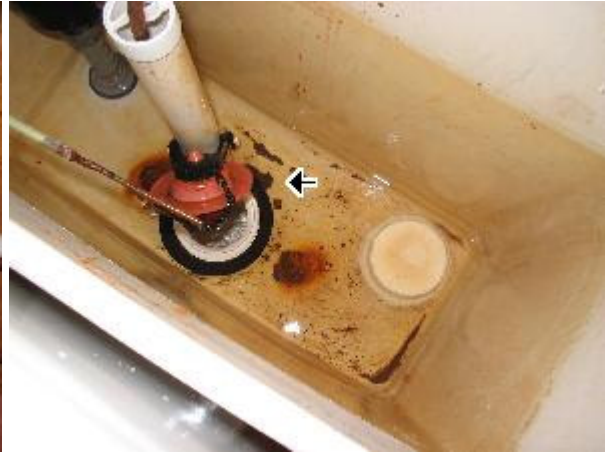
Picture 5

Hall bath toilet flush kit needs replacing due to rust. Picture 4.

Hall bath toilet flush kit needs replacing due to rust. Picture 4.

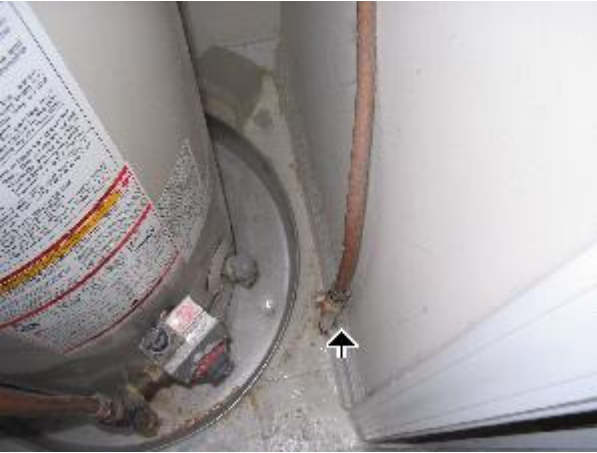
4.2 HOT WATER SYSTEMS, CONTROLS, CHIMNEYS, FLUES AND VENTS

The hot water heater has a gas leak around cut off connection. Tested with gas meter. This should be repaired.

Water temperature appears to be set too high and may scald or injure someone. Recommend reducing to a normal setting.

The hot water heater has a gas leak around cut off connection. Tested with gas meter. This should be repaired.

Water temperature appears to be set too high and may scald or injure someone. Recommend reducing to a normal setting.

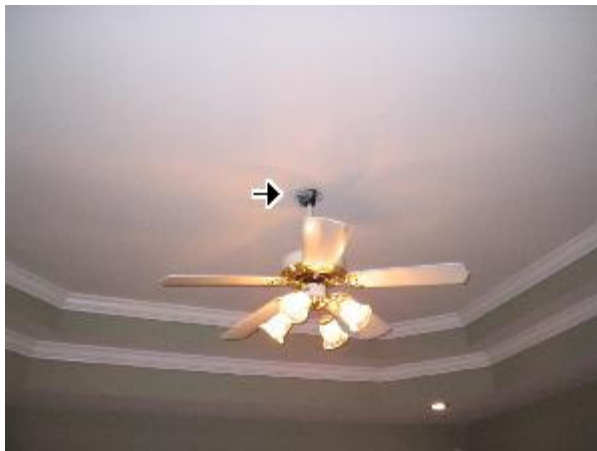
Picture 1

Comments: Inspected, Repair or Replace
The ceiling fan in the master bedroom needs the bell cover put back up. Picture 1.

The ceiling fan in the master bedroom needs the bell cover put back up. Picture 1.

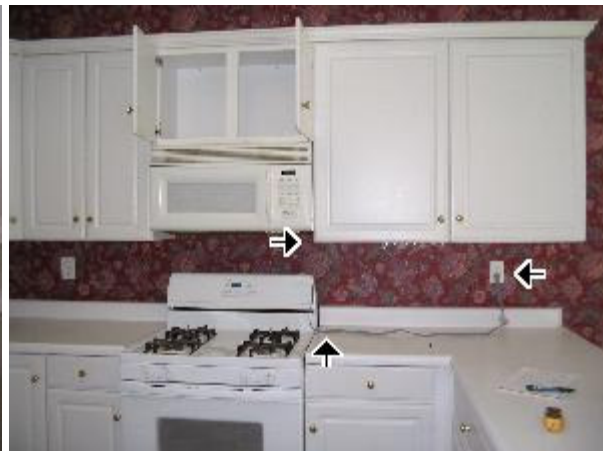
Picture 2

The microwave should have an outlet in the cabinet above instead of a drop cord run to it. Picture 2.

The microwave should have an outlet in the cabinet above instead of a drop cord run to it. Picture 2.

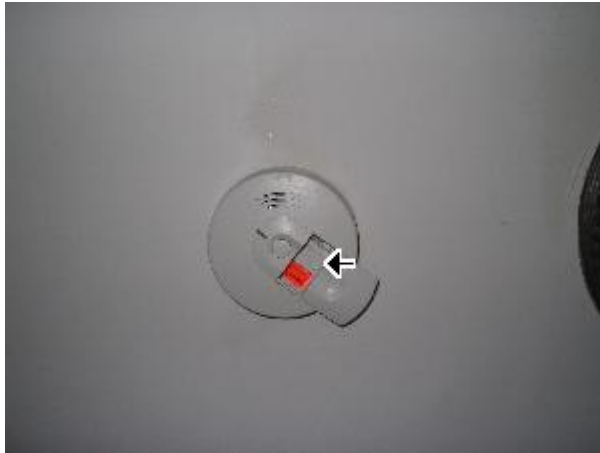
5.6 SMOKE DETECTORS

There is one smoke detector on the main level in the hall that needs a battery installed.

There is not a smoke detector in the basement. Recommend adding for safety reasons.

There is one smoke detector on the main level in the hall that needs a battery installed.

There is not a smoke detector in the basement. Recommend adding for safety reasons.

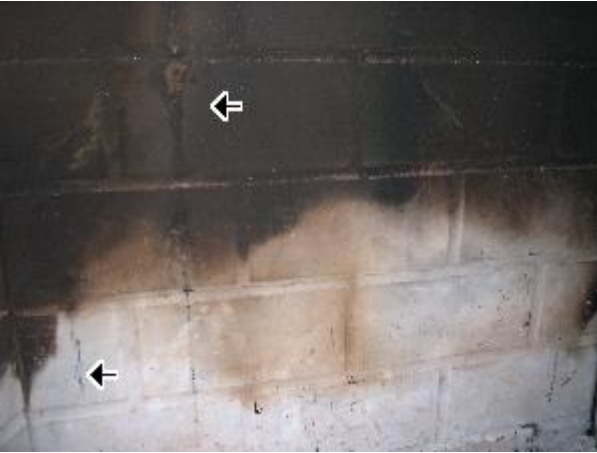
6.6 GAS/LP FIRELOGS AND FIREPLACES

Comments: Inspected, Repair or Replace
The fireplace has some cracks in the fire brick that should be sealed.

Black soot buildup indicates that Gas Firelogs do not appear to be arranged or positioned according to manufacturers specs. If logs are not positioned correctly, carbon monoxide can be produced.

The fireplace has some cracks in the fire brick that should be sealed.

Black soot buildup indicates that Gas Firelogs do not appear to be arranged or positioned according to manufacturers specs. If logs are not positioned correctly, carbon monoxide can

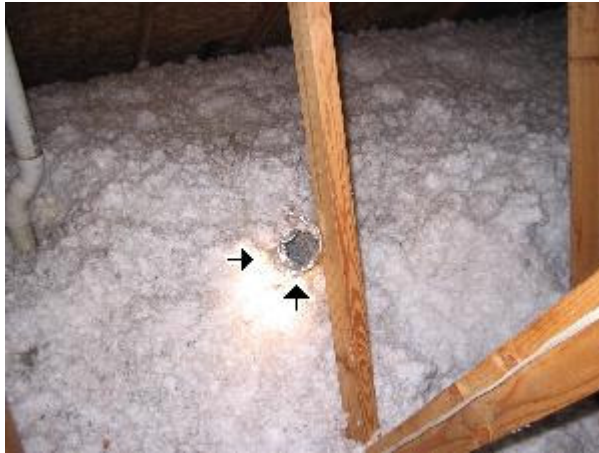
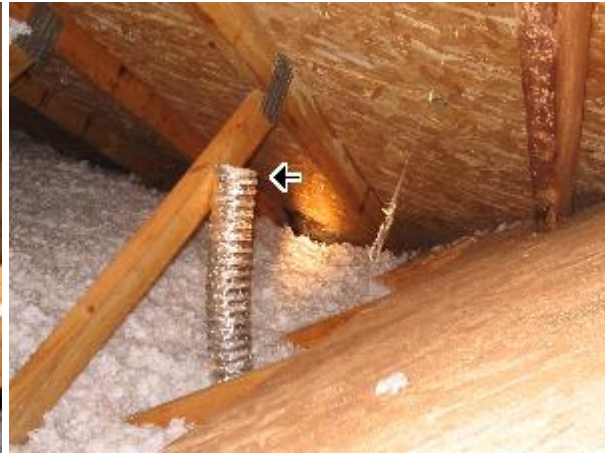
9.2 VENTING SYSTEMS (Kitchens, baths and laundry)

The bath fans terminate in the attic area. These should terminate on the exterior to prevent moisture in the attic.

The bath fans terminate in the attic area. These should terminate on the exterior to prevent moisture in the attic.
